**Three USN Catalina wrecks  
(Catalinas Four, Five and Six)  
Darwin Harbour  
Heritage Assessment Report**

**Compiled by Heritage Branch  
February 2014**

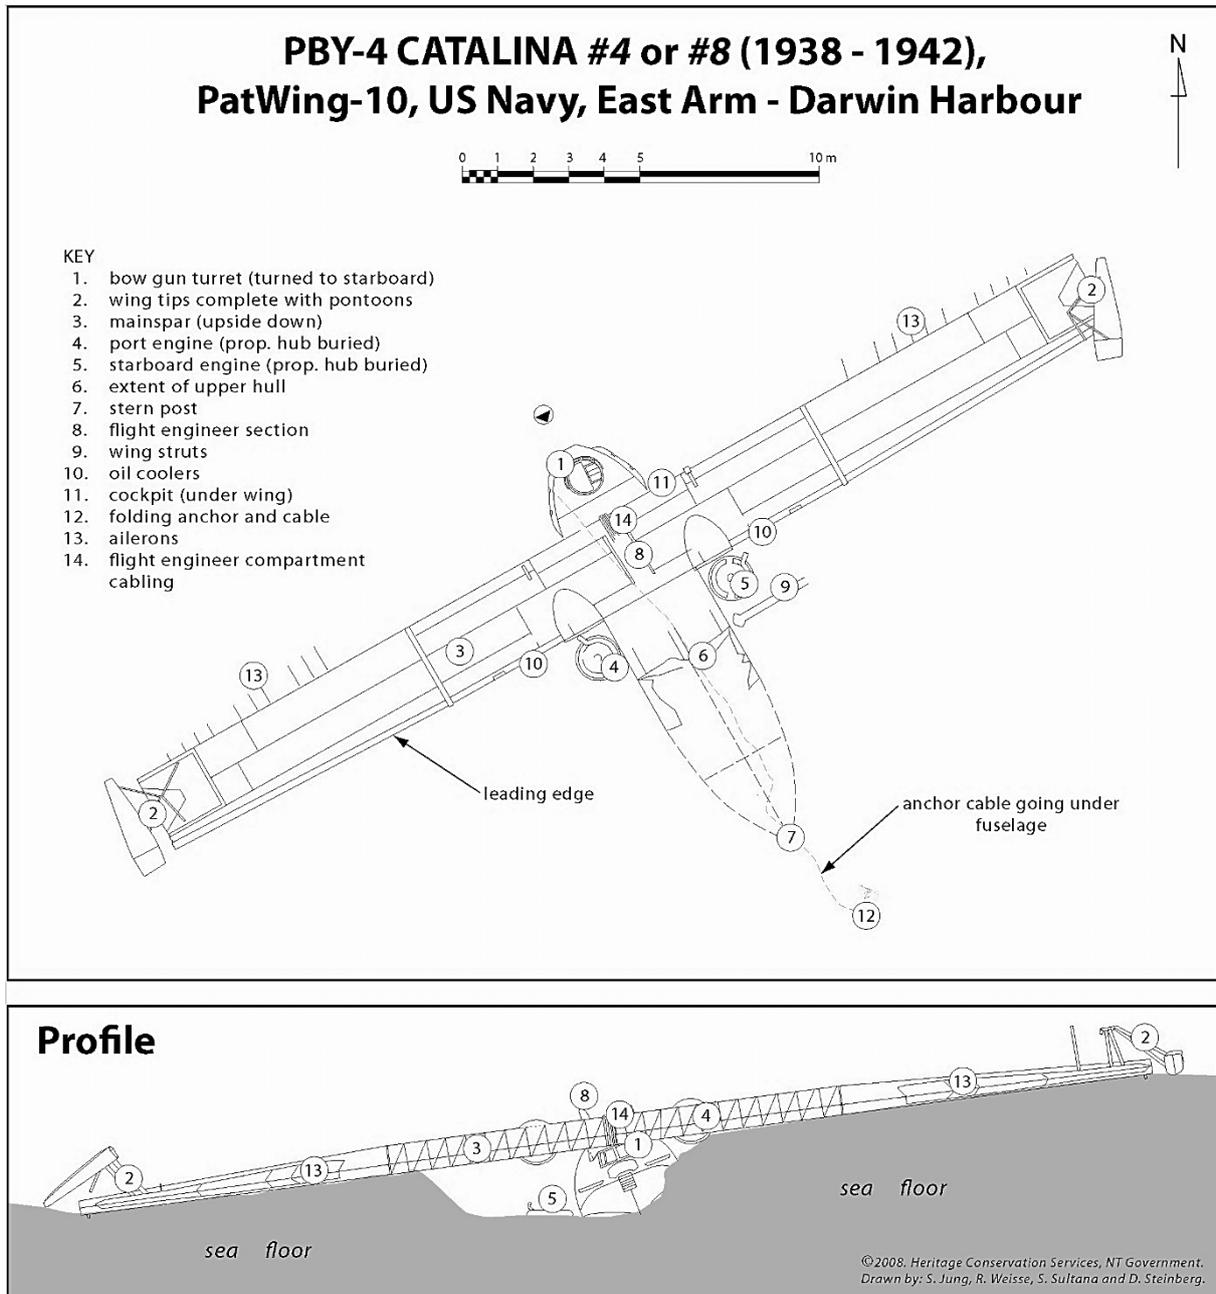
Site plan dates to 2008; changes have occurred since

Catalina Six is still arguably the most intact located Catalina wreck in the Northern Territory, although since it has been discovered it has undergone some considerable changes. In terms of its overall structure it is the least collapsed and broken up. The forward section of the plane's fuselage is sealed and intact, this part housing the forward gunner and cockpit. It therefore has a measurable degree of intactness. This in turn means this particular site has a medium-high degree of archaeological integrity.

The profile view of the site plan shows that the engineering compartment has collapsed and the wing rests on the fuselage. The wing has broken away from the fuselage, flipped backwards and resettled back on top. By chance it rests in about its original position both in terms of its axis (like hands on a clock) and in terms of the middle of the wing being on top of the fuselage. An engineering cable (feature 14) tells us how the wing flipped back and over rather than forward and over. With the wing intact, the wreck shows off the full span of the wing, which was over 30 metres. This is the only Catalina of the six wrecks in the harbour with its wing span intact, and this contributes significantly to this wrecks ability to represent one of the distinguishing features of the Catalina design.

The engines (features 4 and 5) have fallen away from the wing and have landed in the mud in close proximity. Both are upside down with the propellers buried in the mud. These propellers are stainless steel and prized by collectors. The back workings of the engines are visible for study.

Feature 6 on the site plan shows the extent of the roof of the fuselage. Looking under the roof one notes there is a bulkhead blocking access to the forward section. This likely provides structural strength to this enclosed cavity. These would certainly contain material of significant cultural value including controls and personal items. Aft of this section the roof of the fuselage is gone but the lower part of the fuselage is buried in the sediment. Significant material may be buried with the confines of this buried lower part of the fuselage. The stern post is visible, delineating the length or end of the fuselage. The tail section is not connected to the main body of wreckage and was not located.

The loss of the anchor was disheartening signalling the site has been partly salvaged by divers. The structural loss of the turret and pontoon also impact on the site's integrity. The turret and pontoon losses were likely not caused by divers; however it is as yet undetermined whether they were caused by natural forces, or other kinds of human disturbance, such as boat anchors or the propeller wash of large passing ships.

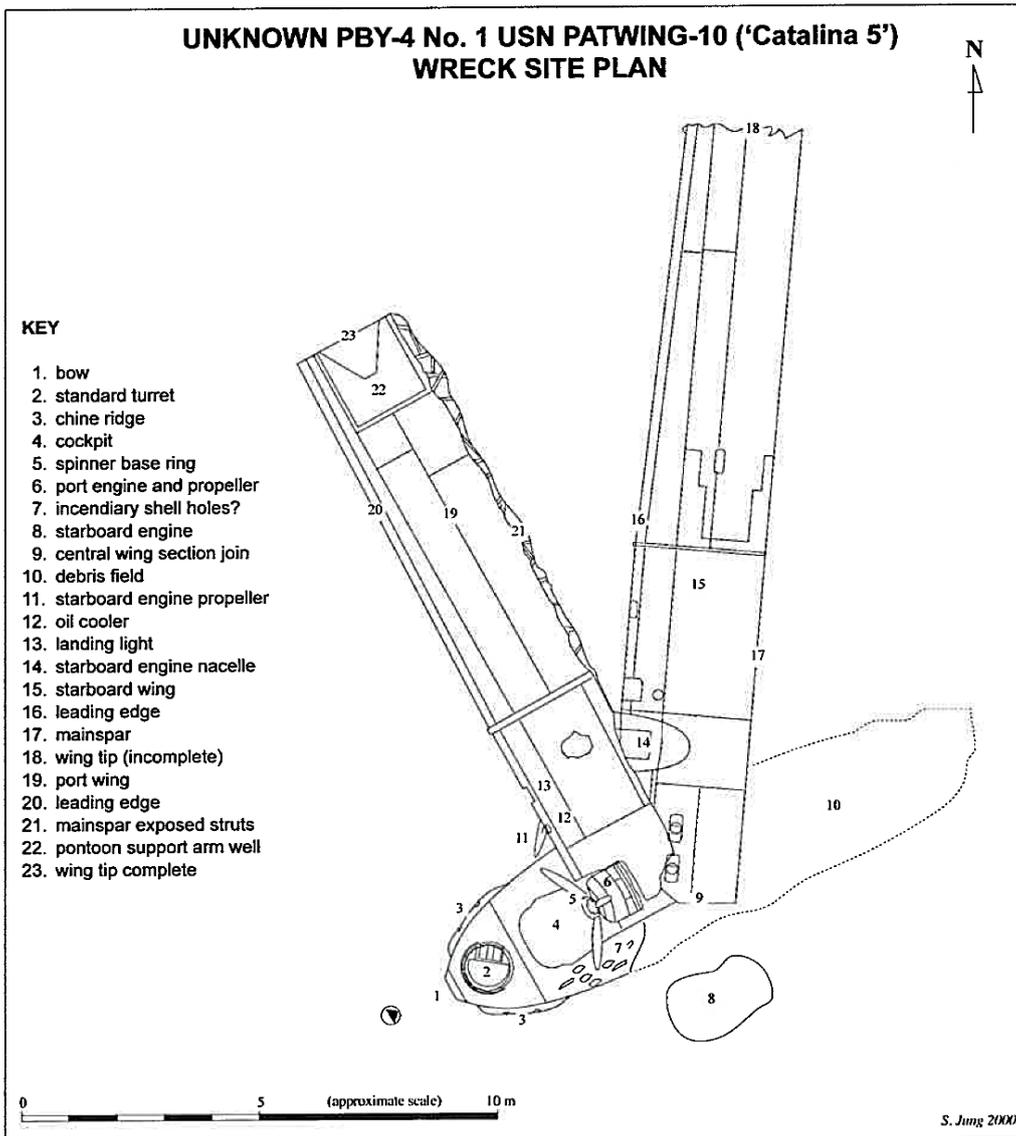
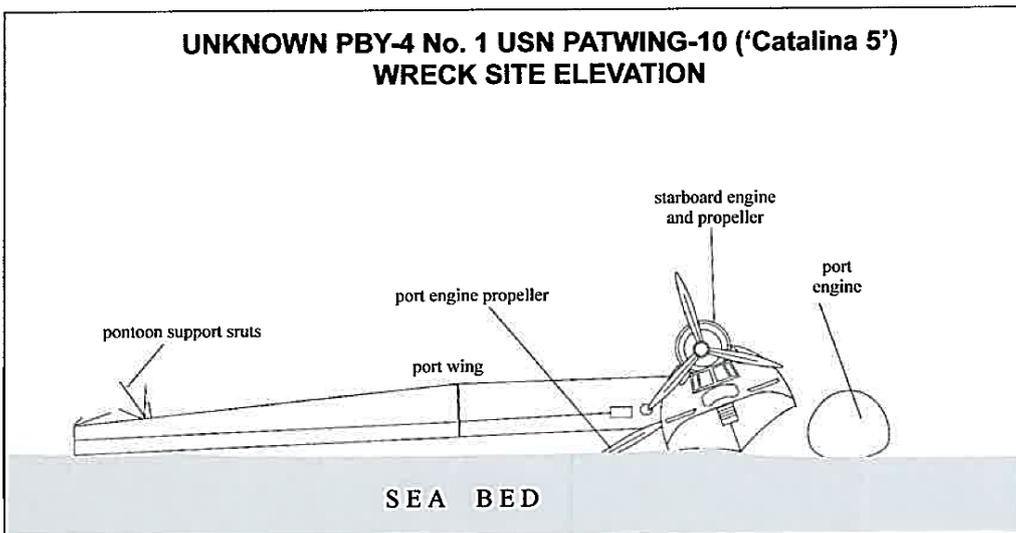
Site Plan dates to 2001; changes have occurred since. Also corrections have been made since (Jung 2001)

Catalina Five sits in approximately 14 metres of water. The site plan shows that the most obvious difference between it and Catalina Six is the wing. The wing is broken in two with the starboard wing in a four o'clock position to the fuselage and the port wing flipped over and back onto the fuselage and starboard wing. Like the wings seen elsewhere on the other Catalinas wreck sites in the harbour, the trailing edges have not survived and only masses of ribs and stringers can be seen along the rear of the mainspar. No pontoons have been located on the wreck site. One engine has fallen into the cockpit. Jung suggest the second engine is to the side of the fuselage (feature 8). However the 2012 survey confirmed that this feature is not related to the Catalina, suggesting the starboard engine may be attached to the wing and covered over out of view. Similar to the other Catalina wrecks the engineering compartment has collapsed. The fuselage lists to starboard in the direction of the wings.

There is no upper hull structure aft of the wings however close to the sea floor the lower edges are visible. The stern post is visible, delineating the end of the fuselage. The tail section is not connected to the main body of wreckage and was not located. The 2012 survey noted that the port wing is greatly deteriorated, with damage likely caused by anchors, and that the sheeting is coming off the turret and fuselage. Also in 2012 Inpex identified Catalina debris, thought to be associated with Catalina Five because of proximity, within its dredging footprint, This was an aluminium box filled with wire components and a pontoon. These were relocated to the Catalina Five wreck site.

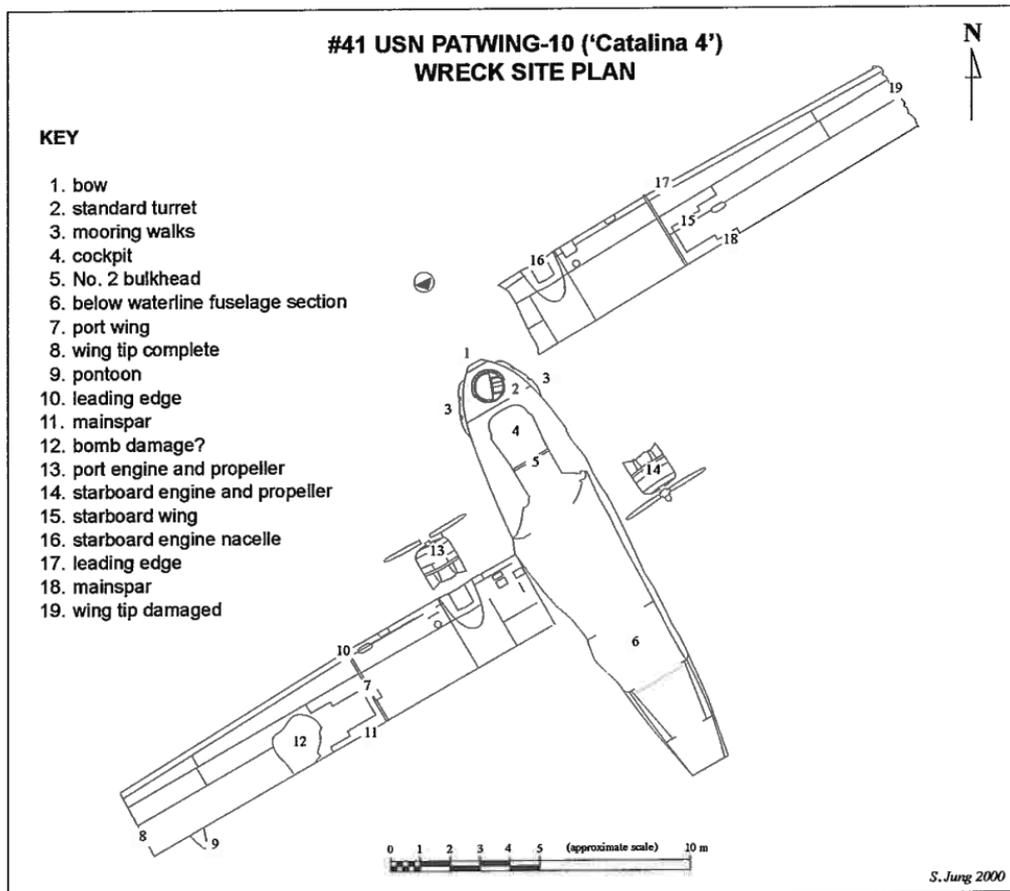
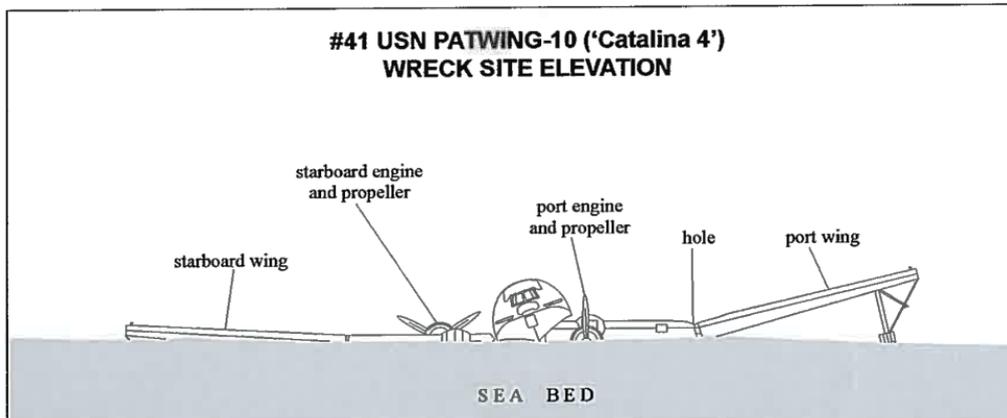
*#41 ('Catalina 4') wreck site plan and elevation.*

This site plan dates to 2001; and changes have occurred since. For example the port wing has been considerably damaged.  
Jung 2001

The 2001 site plan of Catalina Four shows that the engineering compartment has collapsed and the wing is broken in two sections. The port side of the wing appears in a correct alignment with the fuselage. The starboard wing lies forward and to the side of the fuselage with its engine detached and lying further down the fuselage. The 2012 survey confirmed this to be an error. The starboard wing is flipped upside

down and the engine is still attached to the wing. The 2012 site inspection also noted considerable changes to the port wing. The pontoon structure has collapsed. The wing has been torn in two, at the weak point where a hole was identified in 2001 (feature 12). The far end has been torn away and flipped upside down. A 2013 inspection located the pontoon 30 metres S.W. of the wreck. The 2012 report notes many fishing boat anchors on this wreck.
