Analysis of corrosion phenomena on the *Marchinbar* coins

Dr Ian D MacLeod

Western Australian Maritime Museum

11th May 2016

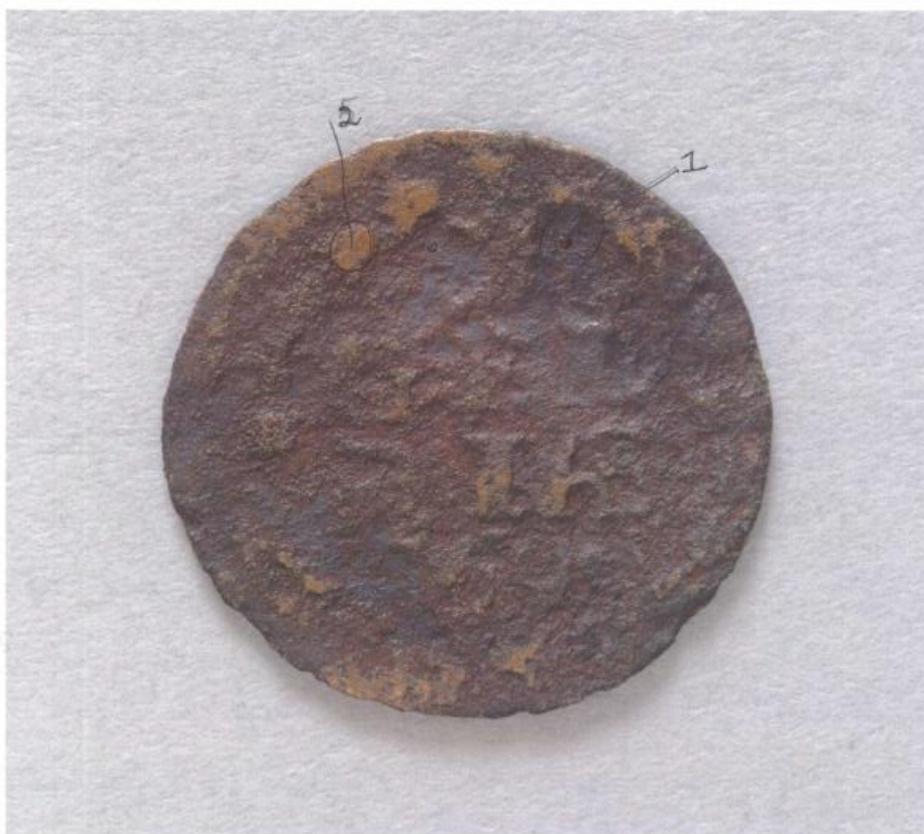
N21359-1
07/12/2015

The Marchinbar Island coins did not appear to have very much encrusted or build-up of corrosion materials, as evidenced by the optical images. The 1690 coin (21359-1) surface had suffered severe corrosion with many signs of deep pitting corrosion and a corrosion matrix that was consistent with the dominant decay products being cuprite (Cu_2O), copper (II) hydroxychlorides of the form $\text{Cu}_2(\text{OH})_3\text{Cl}$, consistent with corrosion in proximity to the marine environment. Consistent with the morphology of the surface deposits there are some halite (NaCl) crystals. Although there was no supportive X-ray diffraction data it is consistent with the EDS spectra that there are also lumps of copper carbonates mixed in with a generally poorly defined crystalline matrix (spot 4 on area 1). A more detailed examination of area 2 (see optical micrograph in file) showed up a generally planar surface with significant amounts of pitting around the grains of the metallographic structure with major intergranular corrosion which has resulted in an essentially fractured surface which is predisposed to attracting dust and thus moisture condensation leading to exacerbation of the underlying corrosion problems. The back-scattered image shows that the general surface is composed of copper and that the intergranular areas (light coloured) are a mixture of CuCl and oxidative and hydrolysis reactions resulting in the $\text{Cu}_2(\text{OH})_3\text{Cl}$ deposits around the grains.

The 1690 coin is a highly corroded and surface modified copper coin which has suffered much from intergranular corrosion which has weakened the surface layers. The presence of halite crystals on the surface attests to the depositional microenvironment being close to the sea. Preventive care of the coin should have it placed in a low relative humidity microenvironment of approximately 30-40 % to minimise future corrosion if the original corrosion products are to be retained for historical purposes and for future research on the mobilisation of trace impurities in the copper through this form of corrosion mechanism.

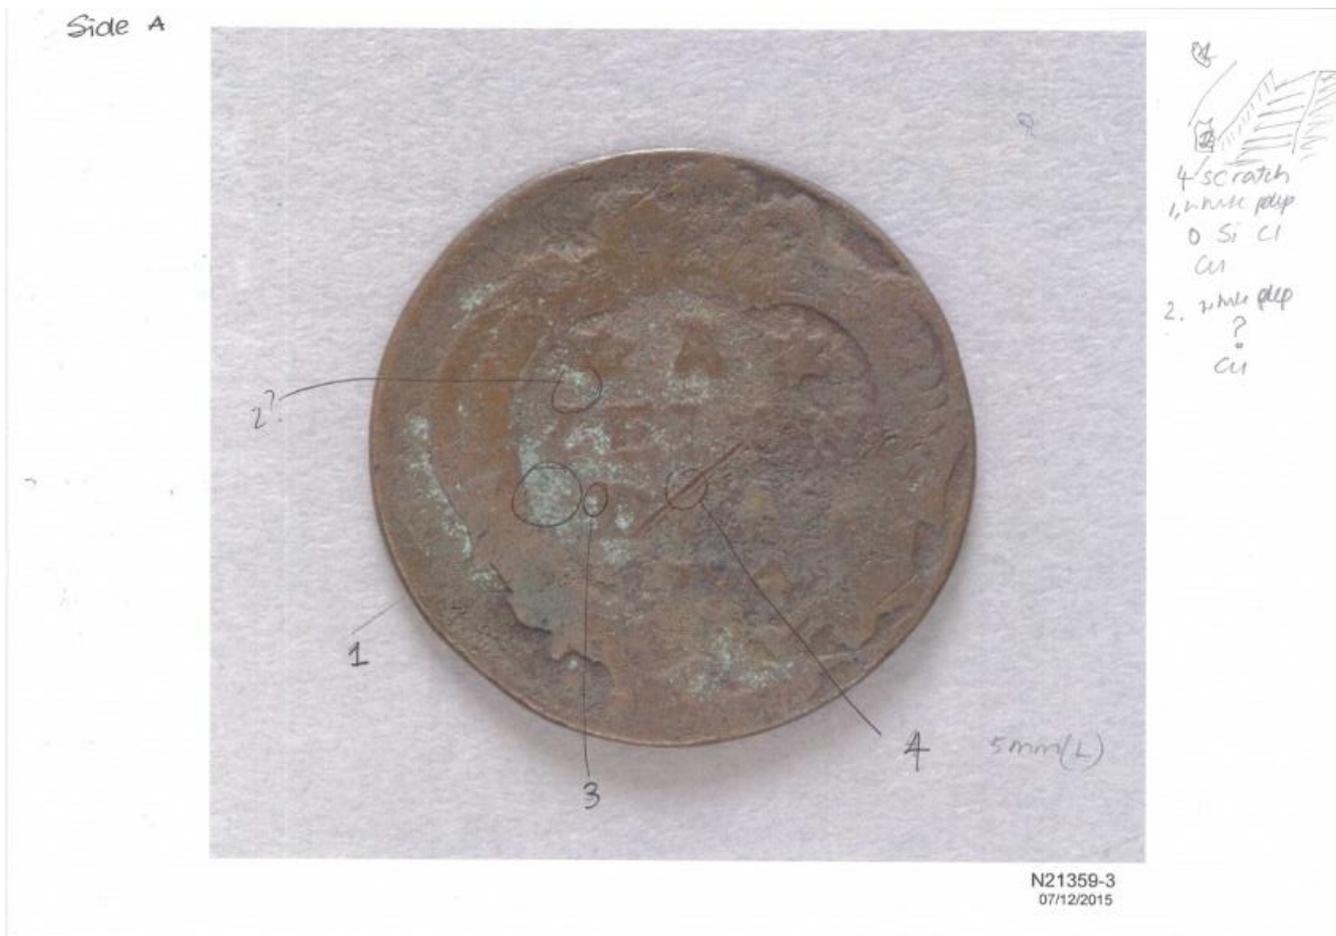
3. N21359-3 Coin, Netherlands, Dutch East India Co., Doit, copper alloy, Zeeland Mint, 1784

The more modern, 18th century, Doit (N21359-3) was the 1784 Zeeland minted coin has reasonably fine crystalline structure which is consistent with either annealing after the coin blank was formed or with some hot working after formation before the blanks were cut from the sheet, though this is a less likely scenario. Typical grain sizes were estimated to be in the range of 8-18 μ m. The light phase is the secondary copper (II) hydroxychloride, $\text{Cu}_2(\text{OH})_3\text{Cl}$, which was readily seen in comparison with the darker phase of cuprite which was the primary corrosion product. The gouge across the surface is consistent with major physical impact such as the grinding of hard rocks or a metal excavation tool across the surface. There is clear evidence of brushing with a series of random scratches consistent with using a stiff brush to remove archaeological debris. It is apparent that the gouge was historic as detailed examination of the surface shows that deep inside the double “v” of the scratch there are localised pitting points with primary copper (I) chloride and the oxidative hydrolysis products of the typical blue-green copper (II) hydroxyl chloride. The highest magnification used showed up the equiaxed nature of the grains of the copper crystals. In amongst the corrosion matrix and materials entrained with the corrosion products there was some silica which again is consistent with long term exposure to a marine environment.

The copper Doit coin is in a significantly deteriorated condition with little to no evidence of any previous conservation intervention as the corrosion matrixes have all the characteristics of an archaeological deposit. As with the case of the 1690 Doit it is recommended that the coin is stored at a relative humidity less than 30-40 % to keep the surface in a stable condition to facilitate more detailed examination of the trace amounts of impurities that have reported to the intergranular corrosion areas.

There is a green-white coloured corrosion material on approximately <5% of the coins surface.

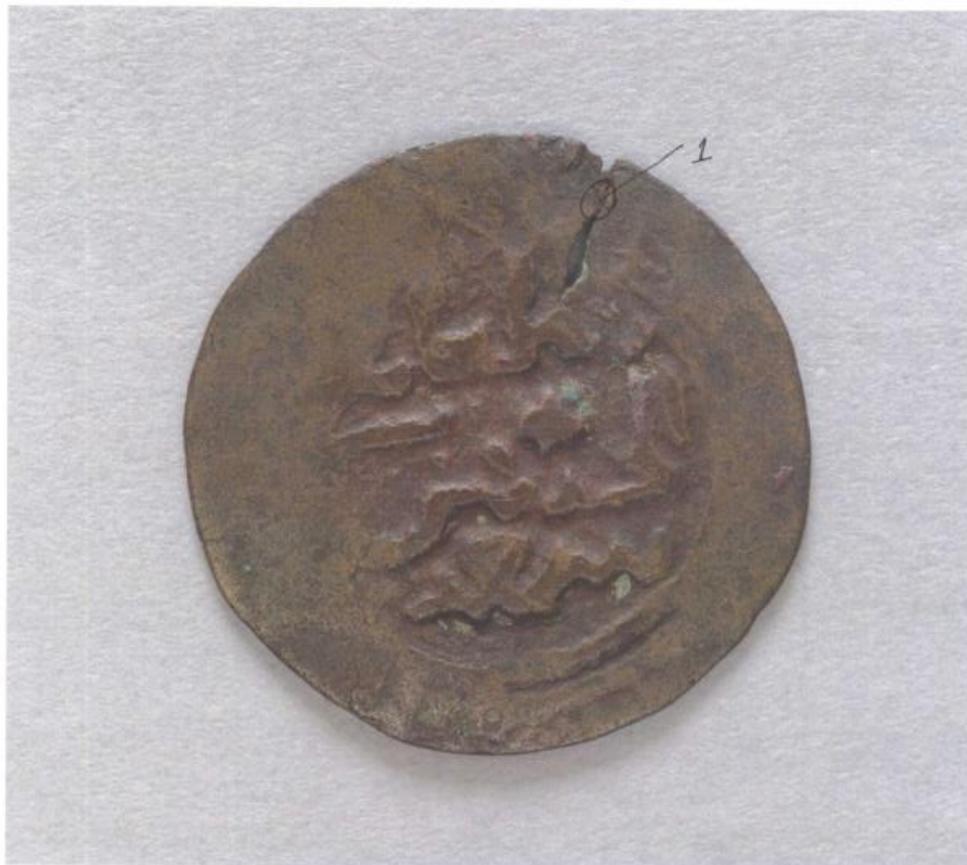
N21359-5
07/12/2015

The oldest coin (213549-5) from the period 1294-1308 had titanium, silicon, aluminium, carbon, oxygen and copper in the cracks and on the surface. It is reasonable to assume that the titanium was associated with “beach sands” such as ilmenite FeTiO_3 . The aluminium and silicon are associated with clay like minerals of aluminium silicates with carbon, oxygen and copper being connected with the aerial oxidation of the primary copper corrosion product of cuprite (Cu_2O) to secondary copper (II) hydroxycarbonates, such as $\text{Cu}_2(\text{OH})_2\text{CO}_3$. Spot analysis on area 4 gave the primary alloying elements of copper and tin along with moderate amounts of silver and lead, both of which are typically associated with sulphide deposits of copper such as chalcocite Cu_2S and covellite CuS , mixed in with galena PbS and the Ag_2S argentite or acanthite. The presence of these trace metals is typical of old bronze coinage. Area 6 just gave copper and oxygen which is consistent with the major surface corrosion product of cuprite. The first area looked at with x400 magnification showed up the presence of multiple phases, with the aluminium likely to be associated with clay-like minerals. This area is dominated by tin corrosion products with the notable absence of chloride which is consistent with corrosion in a land site rather than being in a marine environment. The second spot analysis showed up phases consistent with hydroxycarbonates of copper which had formed along the intergranular cracks in the metal structure in response to secondary oxidation of the initial cuprite patina, as a result of moisture being trapped in the cracks and bringing with it higher concentrations of dissolved carbon dioxide, hence the formation of copper (II) carbonates. On the alternate side (B) there was evidence of a higher amount of lead associated with the copper corrosion products along with the aforementioned clay-like minerals associated with aluminium and magnesium. It is likely that side B was uppermost in the archaeological context since there is preferential corrosion of the copper rich α -phase in which significant amounts of lead were dissolved or had reported to the corroded grain boundaries. Side A with its much higher concentration of tin corrosion products is typical of a downward facing surface of the coin where

This coin has well defined differences in the corrosion products found on sides A and B which relate to different microenvironments in terms of access to areas of higher or lower dissolved oxygen content in the moist soils containing the coins. It is very likely that specific sampling of the different mineral phases present will provide a unique insight into the burial environment from which the coin came. The copper ores associated with the production of the bronze coin have come from a sulphide deposit rather than from an oxidized ore body associated with copper ores in Cyprus and other related locations.

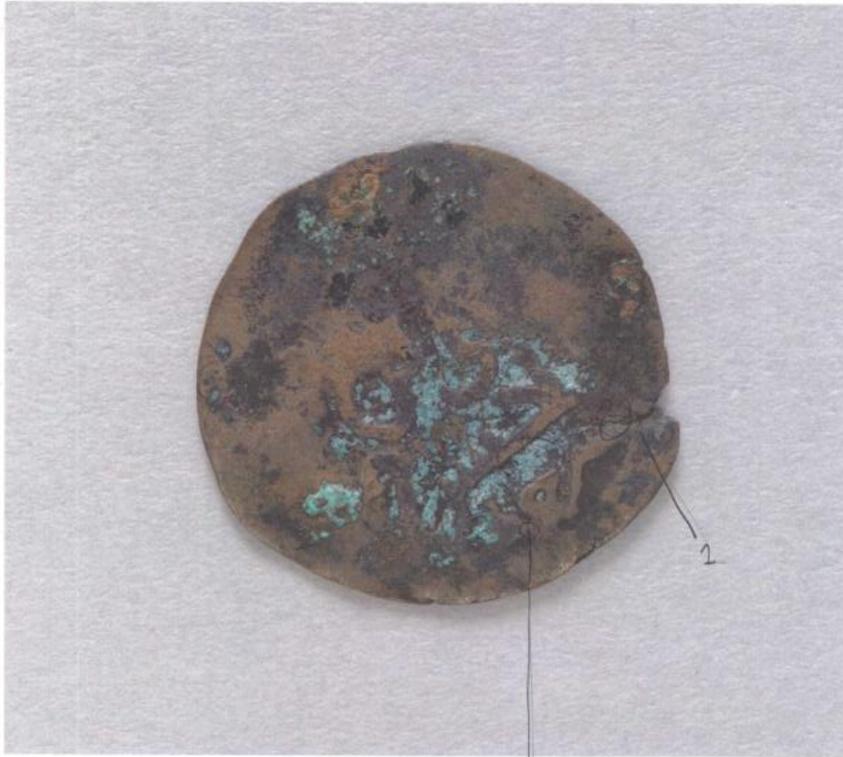
N21359-7
07/12/2015

The second Kilwa coin (213549-7) came from the period of 1480-1482 and the presence of phosphorus amongst the detected elements was most unusual and indicates that it was recovered from a terrestrial rather than a marine site where the concentration of phosphates in seawater is very low, certainly too low to have a high enough concentration to precipitate a mineral phase. Under x4000 magnification it is clear that the surface is covered with a complex matrix of corrosion products which included copper, calcium, sulphur, carbon and oxygen. The presence of such a milieu of phases is consistent with some significant changes occurring during the depositional time of the coin in its archaeological context and so sampling of the phases to characterise the minerals that are present, using x-ray diffraction, is an essential step in unravelling the corrosion history of the object. Under the x40 secondary electron image of the coin it is seen that the micromorphology of the corrosion products is a reflection of the underlying structure of the coin. One of the corrosion masses was formed like a mesa which is likely to be a specific mixed copper carbonate phosphate. Like the other 13th century coin, the presence of lead in spot 17 in association with copper and tin is likely a reflection of corrosion of the dendritic phase under low oxygen conditions. The areas of spot analysis numbered 18 and 19 reflected copper, aluminium and oxygen which are indicative of clay like minerals and cuprite as a corrosion product. The morphology of the underside of the coin (B) has pustular growths of copper (I) oxide along with adventitious alumina so it is likely that side B was uppermost in the deposit that entrained the coin. The semi-quantitative SEM-EDS analyses do not readily transform into discrete empirical formulae associated with well-established corrosion products on bronze objects recovered from a terrestrial site.

The coin has a very complex corrosion matrix and it should also be further investigated by X-ray diffraction as the presence of measureable amounts of phosphorus is very unusual in a bronze coin matrix. Given the solubility of phosphate minerals it is most likely that this coin was also recovered originally from a land site and that the source of the phosphorus may relate to bird guano. The absence of chloride ions strongly supports the supposition that corrosion was dominated by dissolved oxygen with the bronze coin being buried in a soil that contained the normal range of clay minerals (alumino-silicates). The difference in the composition of the surfaces also indicates which zone was uppermost and which was buried deeper in the depositional microenvironment.

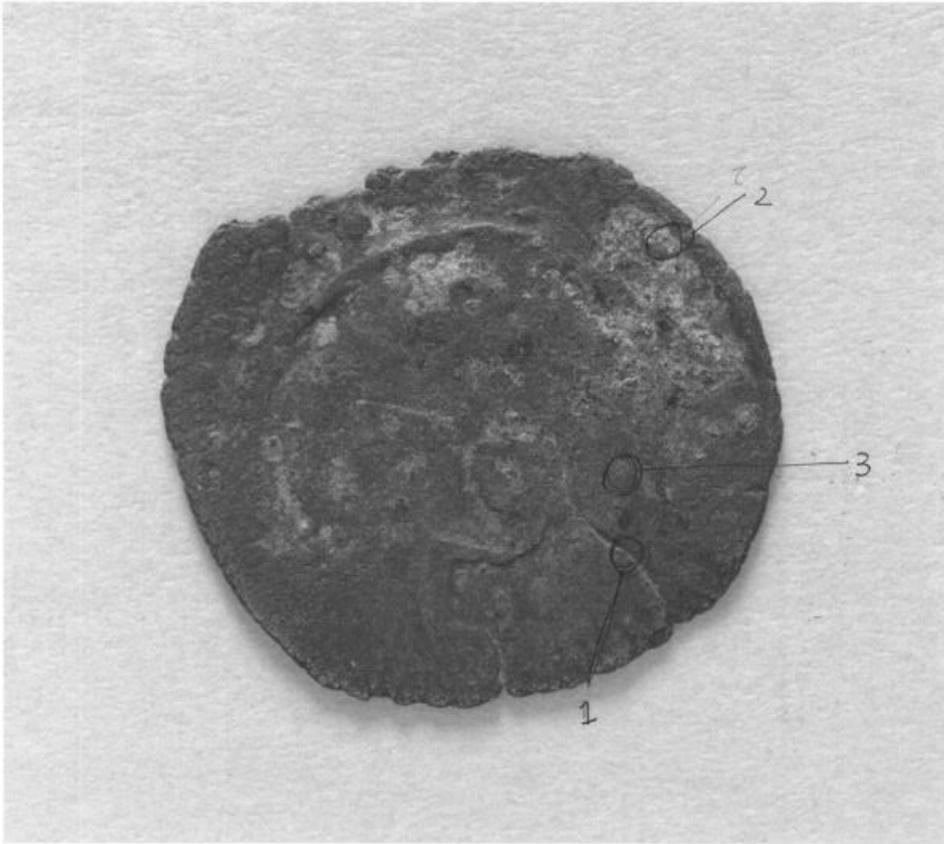
N21359-9
07/12/2015

The coin examination was limited to one side so it is not possible to determine which side was uppermost in the burial environment. The absence of tin decay products is a clear indication that there was selective attack on the copper-rich α -phase, which is kinetically more readily attacked in a richer oxygenated environment. The absence of entrained clay minerals indicates that the burial environments of the two 15th century bronze coins were different. The presence of measurable amounts of phosphorus indicates that the site may have been very close to some bird guano deposits.

Appeared to be the most damaged of the Kilwa coins.
