**SETTLEMENT OF SOLITUDE:
AN ASSESSMENT OF THE SITE
OF FORT WELLINGTON, RAFFLES BAY**

Clayton Fredericksen and Colin De La Rue

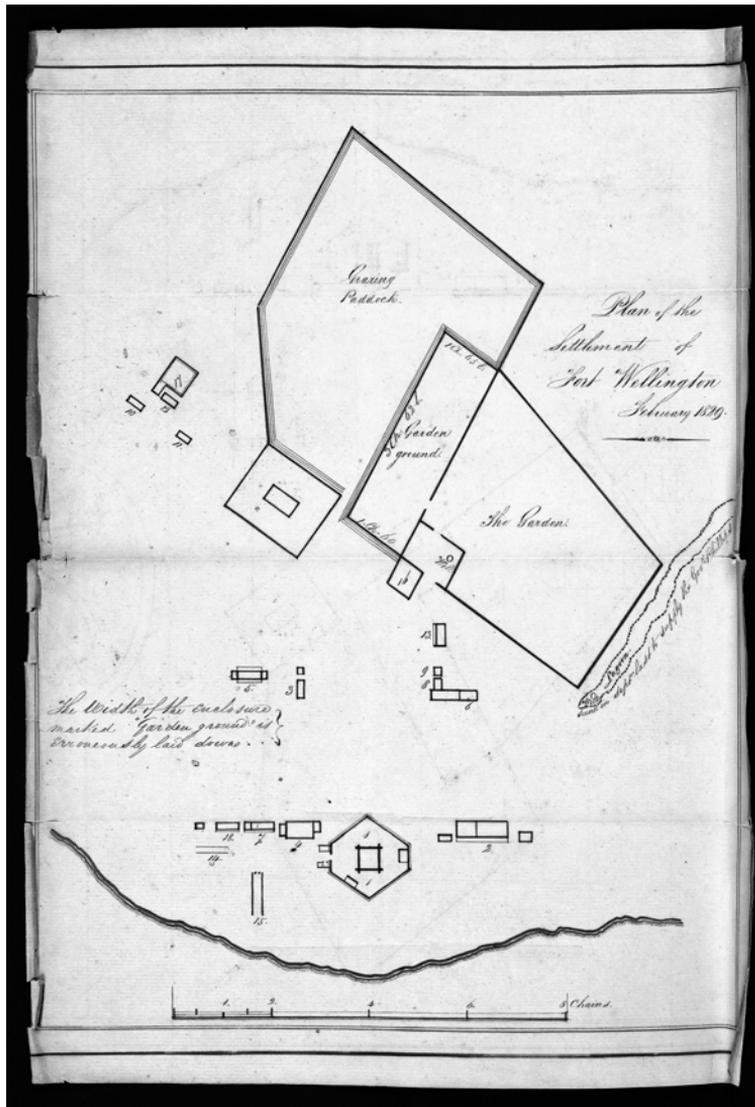
Figure 2. 1829 plan of settlement (NSW State Archives NRS906 [4/2060.2])

Dispersed around the Fort Wellington stockade was the settlement itself. This is represented in a plan recently discovered by Dr Ruth Kerr in the NSW State Archives and published for the first time by Dr Brian Reid (Reid 2011: Figure 12). It is published here as Figure 2 and depicts a hexagonal fort (stockade) immediately behind the coast in close association with six other numbered structures. A return of buildings of August 1829 identifies these as (from left to right) saw pits (14); long hut for Crown prisoners (18); boat sheds (15); long hut for Crown prisoners (7); Commissariat issuing store & storekeeper's quarters and commandant's office (4); and a barrack for the 39th Regiment

(2). Behind the fort are depicted gardens and a paddock and scattered other structures. These are identified as follows: hospital and surgery with attendant's dwelling (5); a barrack for the Royal Marines with a detached cookhouse (3); guard house (6); six small huts for married soldiers (8, 9, 10, 11, 12, 13); a shed for cattle (16); and sheds and styes for pigs (17). A well is depicted near the cattle shed and garden.

As summarised above, historical records provide detailed descriptions of individual buildings and the stockade at particular points in time. The 1829 plan contributes a spatial element to this information. However, upon interrogating written accounts and the plan, a number of discrepancies become apparent. The first of these concerns the size of the stockade. The stockade was described by contemporary observers as possessing sides averaging 45 feet in length encompassing a tower measuring 20 feet on each side (refer above). However, the 1829 plan shows the sides of the stockade as approximately 65 to 70 feet long (one chain = 66 feet) and the tower more than 10 feet wider than described. Other buildings appear to be represented at the correct scale. Interestingly, a similar discrepancy exists on an 1827 plan of the Fort Dundas settlement (De La Rue 2007: 43), in which the size of the fort itself is considerably greater than was the case. It seems the size of fortifications may have been deliberately exaggerated in British military plans of this period. Uncritically using such plans as a basis for determining the location of the remains of fortifications and other structures is likely to be problematic.

Turning to the cutting in the coral reef, this is unlikely to be represented by the boat sheds tagged as '15' on the 1829 plan. The size of the boat sheds (36 feet by 12 feet) and inland location do not support this thesis. Commentators have assumed that the cutting was used to facilitate boat landing but the opening is only six feet wide, very narrow for this purpose and it appears an illogical use of resources to excavate through the reef when perfectly adequate beach landings are available in the near vicinity. A perhaps more plausible function is that of a chute for

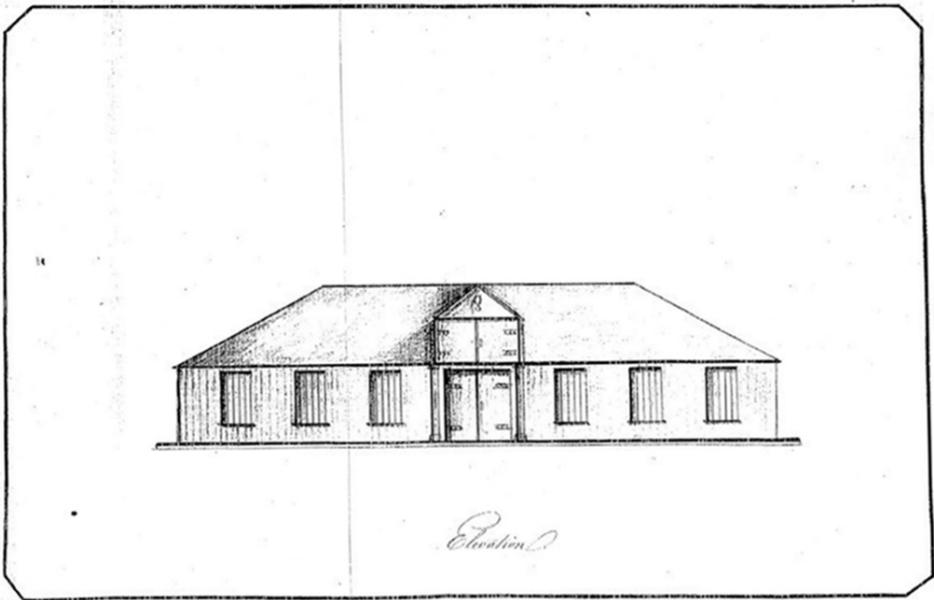
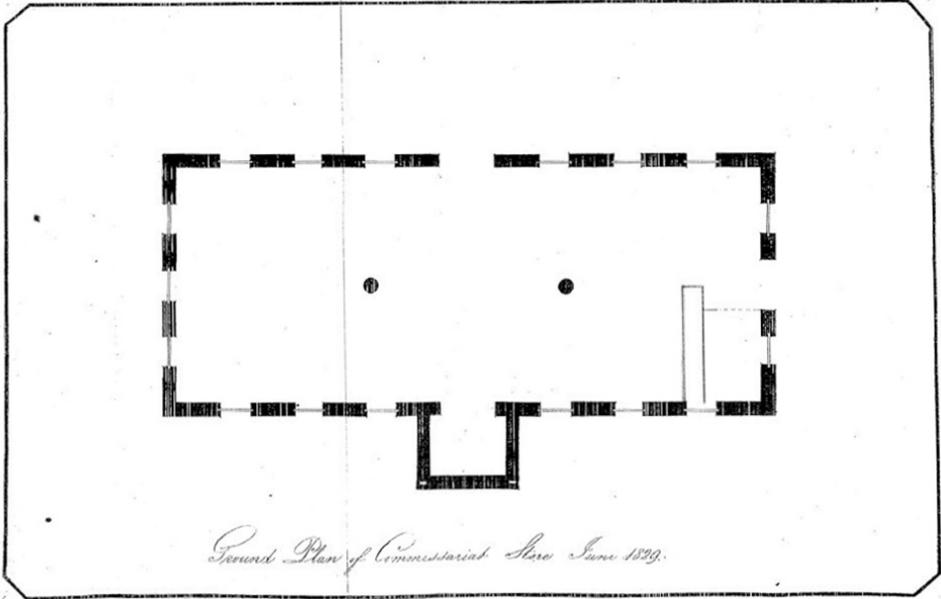
Figure 5. Plan and elevation of the Commissariat Store, 1829 (NSW State Archives NRS906 [4/2060.2])

The "shanty town" description is apt as many of the buildings were rudimentary and poorly constructed affairs. In his journal, Collett Barker remarks on complaints received from members of the 39th Regiment that their barracks were cold and poorly insulated, owing to gaps which had formed between the logs of the walls (Mulvaney and Green 19992: 174). The NSW State Archives possesses floor plans and elevation drawings of a number of the settlement's buildings and these provide a more favourable perspective on at least the formal structures erected. An 1827 plan of the hospital (Figure 3) matches the description given above, with the added detail of verandahs on two sides and what appears to be a shingle roof. The store is recorded as possessing four rooms – a large general storeroom, two smaller storekeeper's rooms and a small Commandant's office – and a front verandah 8 foot long by 8 foot wide. It is probably the building depicted in a plan and elevation drafted in 1827 (Figure 4). The building mentioned above as the 30 foot long storehouse that was almost completed when the order came for the

settlement's evacuation is probably the commissariat store, depicted in an 1829 plan and elevation (Figure 5). The hut occupied by Sergeant Milward of the 39th Regiment in 1827 (Figure 6) was a basic affair of only two rooms, but still approximately 24 feet long by 12 feet wide and possessing a front verandah. The roof of this dwelling appears to have been made of a different material to the roofs of the hospital and store, and was perhaps thatched.

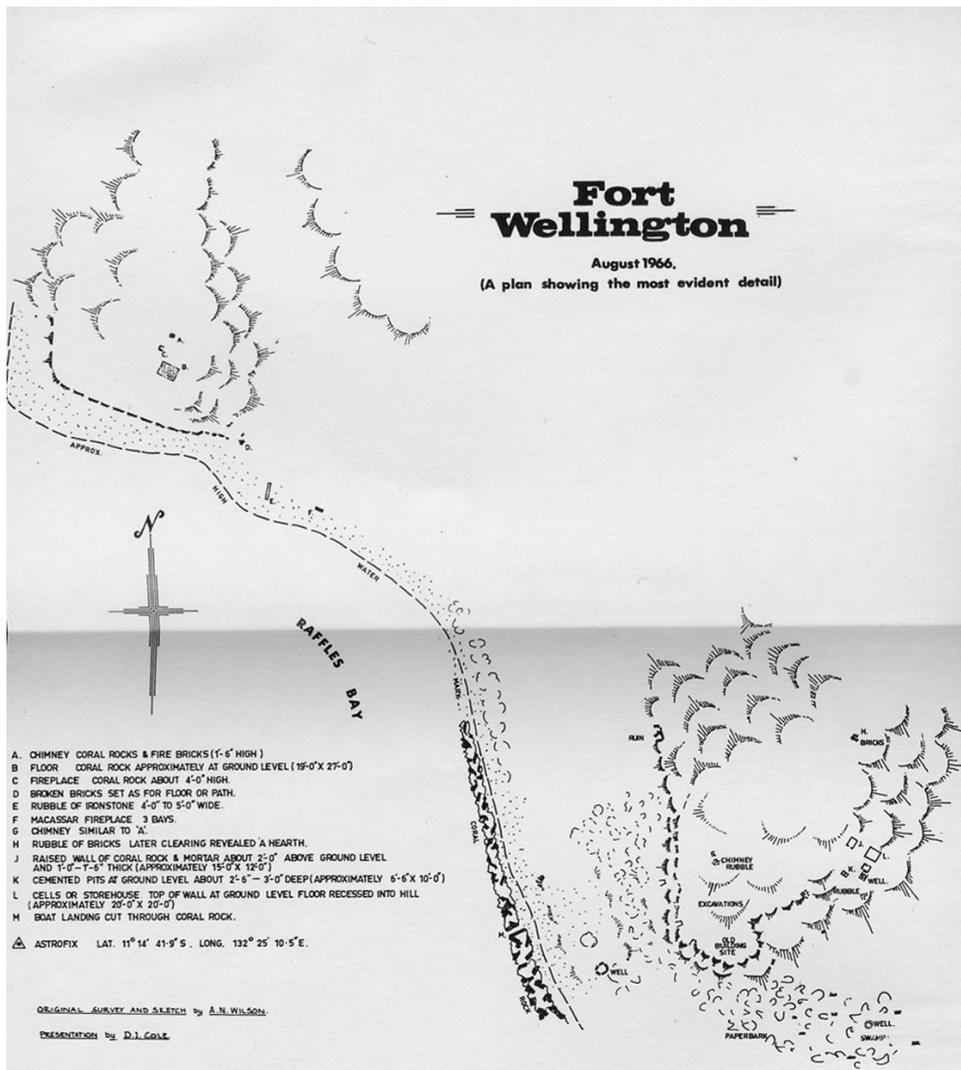
Figure 7. Plan produced by the 1966 Northern Territory Historical Society expedition (HSNT)

The Historical Society of the Northern Territory carried out the first detailed investigation of the surviving fabric of the settlement in 1966 (Historical Society of the Northern Territory 1971). A dispersed settlement was identified, with two main concentrations of features (Figure 7). On the headland at the northwest end of Raffles Bay an extensive coral rock floor was discovered, measuring 27 by 19 feet, along with the remains of two chimneys/fireplaces of coral rock and fire bricks. This high headland provides a commanding view out to the entrance to Raffles Bay, as well as back down the bay. Here, the investigators concluded, was the site of the hexagonal stockade and Commandant's house.

Most of the remaining fabric was found in the southeast part of the site, distributed along a ridge behind the beach. Here remaining fabric included floors of rubble, coral and brick; brick chimney remains; a walled structure made of coral; wells; cisterns or pits; excavations; and a passage formed through the coral reef to allow small craft to be drawn up onto the beach. The investigators gave the following description of the most intact features in this part of the site:

Three further investigations were carried out in 2008, 2009 and 2010, all organised by the Historical Society of the Northern Territory. The objectives of these are presented in Reid (2011: 42ff) and were largely focused on answering three questions: (1) whether further surviving fabric of the settlement exists further inland; (2) the temporal relationship between the settlement, a coral-walled structure (S8, refer Table 1 above) and concrete cisterns (S10, S11 and S12); and (3) the question of the location of the stockade. Mixed results were achieved. An expanded survey inland found no further evidence of the settlement, or the historically-recorded gravestone of Dr Cornelius Wood which was a major objective of the survey. The age of the construction of S8 and S10-12 was unable to be conclusively discerned, a question that may be resolved after analysis of samples taken from the structures (Reid 2011: 45). More success has been claimed for the identification of the settlement's stockade. Participants in the 2009 and 2010 investigations, aided by the 1829 site plan, found artefacts and other fabric on a low dune immediately behind the beach. This was claimed to provide strong evidence of the site of the stockade (*ibid*). The posited location is in the vicinity of the cutting through the fringing coral reef, identified as a 'boat landing' in the 1966 investigation (M in Figure 7).

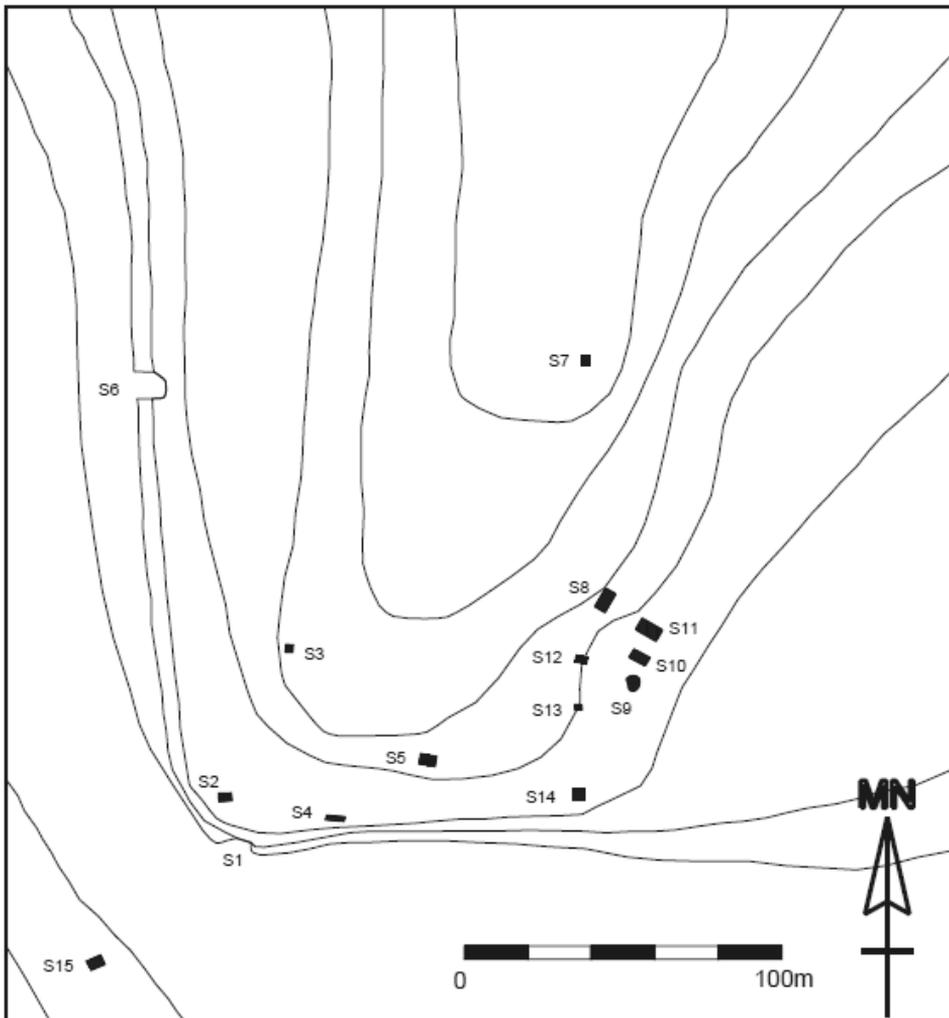
Figure 8. Previously unrecorded remains identified by the 2003 investigation (area shown is limited to the southeast part of Figure 7)

Twenty locations of surviving physical fabric were identified and assigned an individual Structure Number (S1 to S20), recorded on steel star pickets that were implanted as permanent markers. Not all features identified by the 1966 investigation could be relocated, including a Macassan fireplace and ironstone rubble arrangement identified in the northwest part of the site (Features E and F in the 1966 survey plan; Figure 7). However, five previously unrecorded locations of surviving fabric were identified and recorded (Figure 8). Table 1 presents a comparison of the results of the 2003 investigation with investigations in 1966 and 1999.

An argument can therefore be mounted that the cisterns are Dewar's tanning vats, with the smaller of the three structures (Figure 12) perhaps a pickling tub for meat. A nearby well (S9) and other less distinct features in this area (e.g. S13 and S14 – Figure 8) may also relate to the buffalo hunting period. A hearth (S7) is outlined with a twin row of quite well-made bricks and may have been the base for a sheet iron chimney of the type common in the late 19th and early 20th centuries. It may indicate the position of the 'homestead' of Dewar and partners; references to a homestead and substantial camp are present in the *Northern Territory Times & Gazette* for 1876 and 1917. The strong likelihood that there is an overlay of early 1870s re-use over the mid 1820s occupation introduces a complicating factor in identifying the date and purpose of several elements of the site's remaining physical fabric.

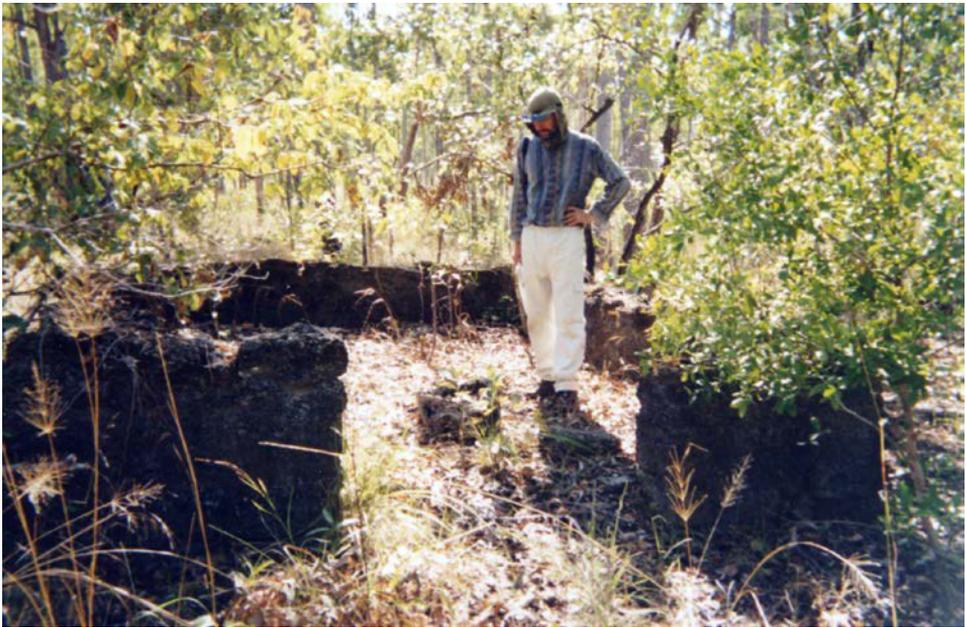
Figure 9. Coral-walled structure (S8) (Photo: Sheryl Oxford, 2003)

The absence of the coral-walled structure and cisterns from the 1829 plan and historical descriptions is puzzling as their construction must have entailed considerable use of resources. The coral-walled structure was built using rough cut coral rock cemented with lime mortar, which fits with building techniques of the 1820s (Figures 9 and 10). Various interpretations have been given to its use, including as a storehouse or armoury (Historical Society of the Northern Territory 1971: 11). The substantial nature of the construction may also indicate use as a prison. Documents relate the construction of cells under Barker's command, which were demolished upon abandonment of the settlement. However, an 1829 plan of prison cells depicts a configuration quite unlike the coral-walled structure (Figure 11). Barker's description of prison cells with two rooms with separate entrances (Mulvaney and Green 1992: 189) is also not reflected in

Putting aside discussion of function, no firm evidence is present in the available historical sources to suggest that the British at Fort Wellington excavated the cutting. One area of interesting research would involve determining whether the rock from the cutting was used to construct the coral-walled structure (S8), thereby linking these two features in relative time.

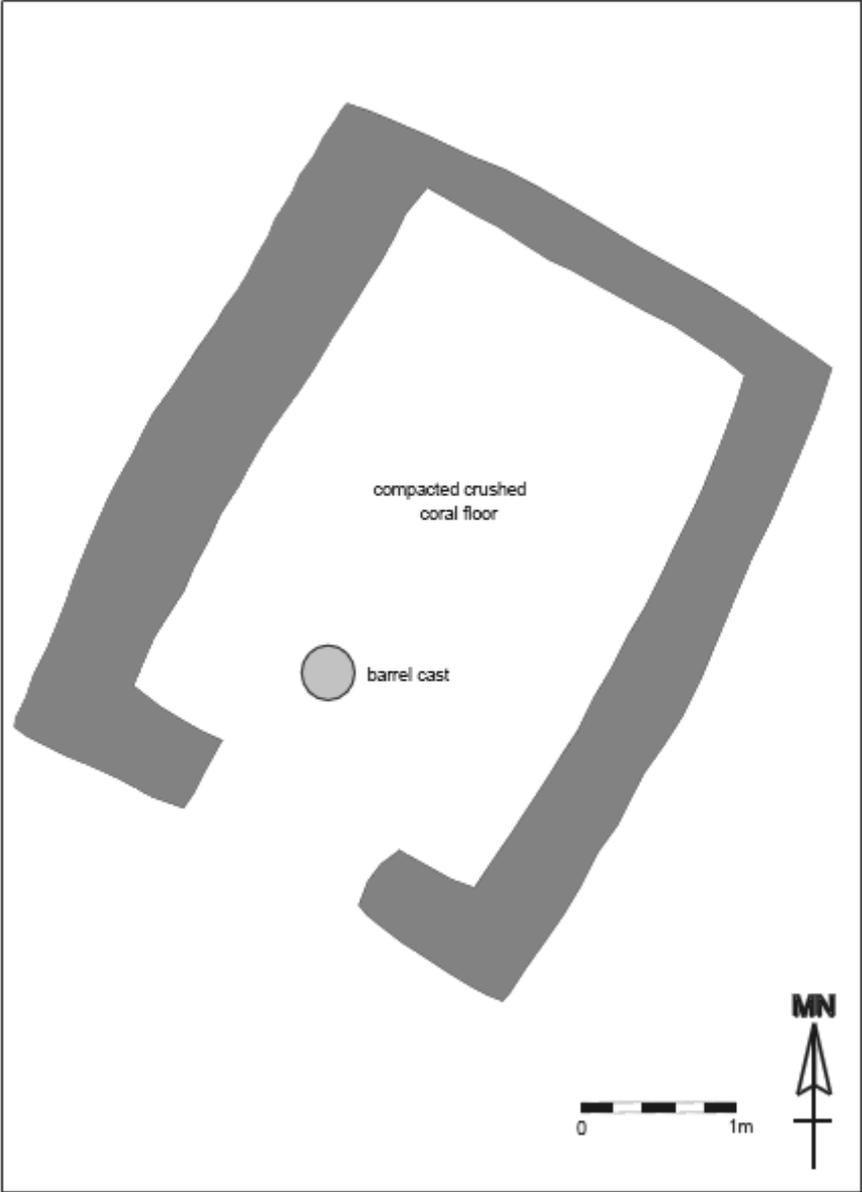
Figure 10. Plan of coral-walled structure (S8)

the architecture of the coral-walled structure. The simple answer is that we do not know when this structure was built or what it was used for.

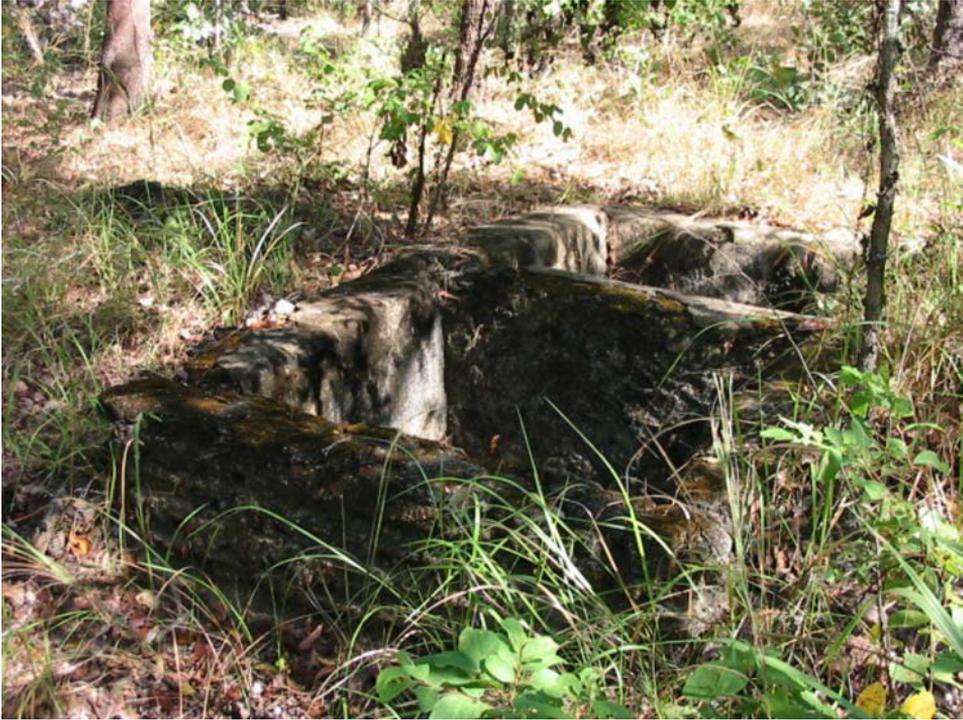
Figure 12. Double compartment cement-lined ‘cistern’ (S12) (Photo: Colin De La Rue, 2003)

The 'cisterns' - S10, S11 and S12 - are even more architecturally significant structures, consisting of semi-subterranean structures lined with coral rock and cement render (Figures 12 and 13). The presence of cement render suggests an age no earlier than the 1870s, when the use of cement became common. The possibility that cement was applied during a later period of re-use cannot be altogether discounted. Nevertheless, the absence of the cisterns from the 1829 plan can be persuasively explained by construction after the abandonment of Fort Wellington. As recounted above, historical records show that during the mid-1870s Fred Dewar and partners were active in this area. They are known to have shot approximately 1000 buffalo between Raffles and Mountnorris Bays and tanned the hides in vats at the site of Fort Wellington (Calaby 1975: 16). The physical remains of this activity are likely to survive at the site.
