**Three USN Catalina wrecks  
(Catalinas Four, Five and Six)  
Darwin Harbour  
Heritage Assessment Report**

**Compiled by Heritage Branch  
February 2014**

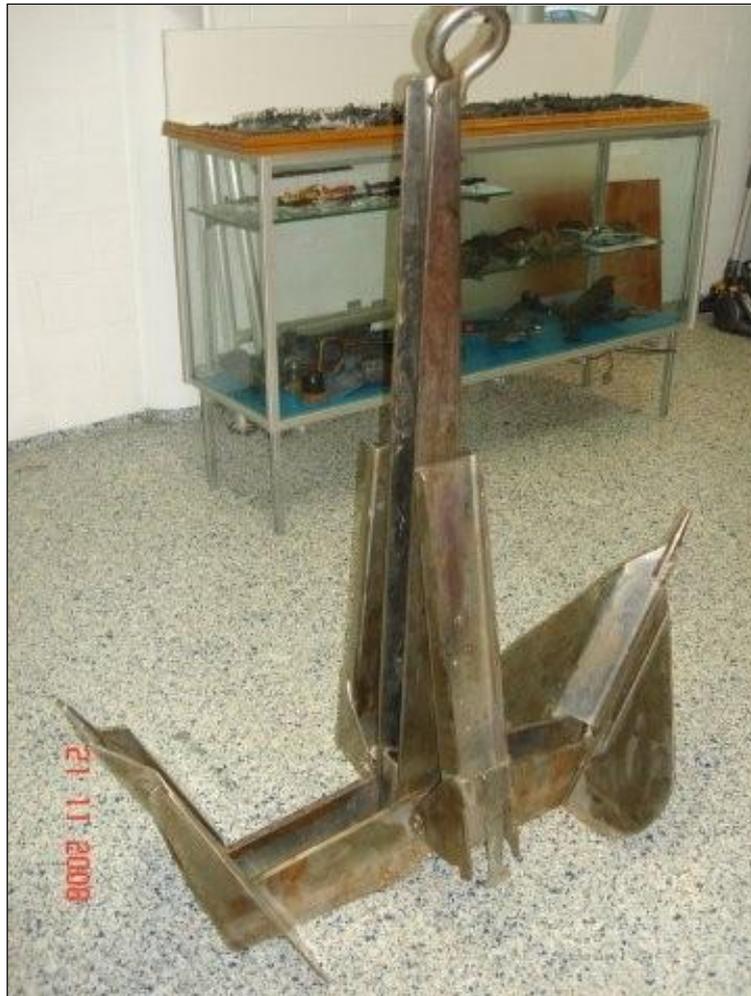
Leading away from the wreck in a SSE direction is the mooring chain which leads to the buried mooring anchor. Catalinas carried a smaller mooring anchor in flight, which was stored in a forward locker. The mooring chain however leads to a larger anchor. These larger anchors were deployed by the boat tender crew that serviced the Catalinas. Both the small and larger anchors are stainless steel.

Example of a larger mooring anchor,  
taken from another Catalina wreck site in Darwin Harbour
